# PETROLEUM HYDROCARBON CONTAMINATION INCIDENT AT CHRISTCHURCH CITY COUNCIL GROUNDWATER PUMPING STATION

*G. Knogle; Pattle Delamore Partners Ltd  
A. Beard, B. Henderson; Christchurch City Council*

## ABSTRACT

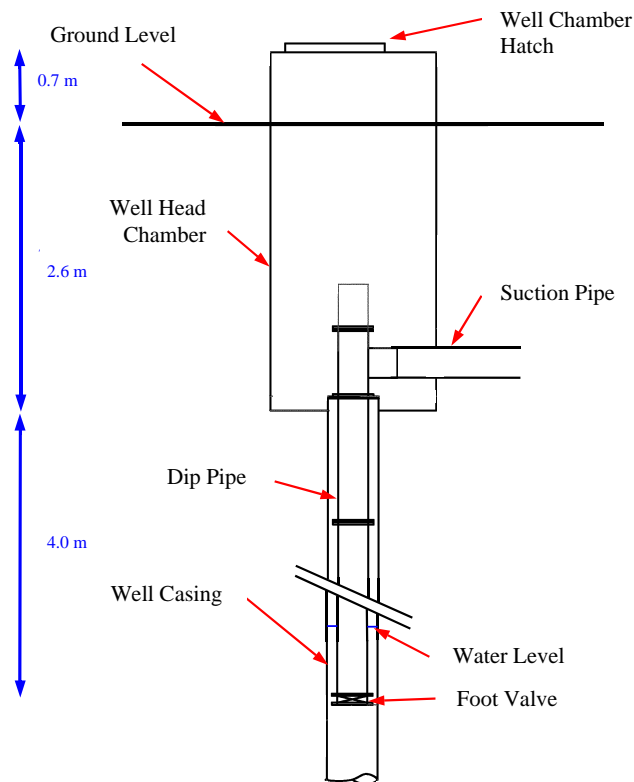
Figure 2: Schematic Diagram of Well No. 4

In addition, petroleum staining was noted on the walls of the concrete well head chamber of Well No. 4 to a height of around 0.3 m above the chamber base and a thin layer of diesel was noted floating on water present at

the base. The base of the well head chamber of Well No. 4 is around 2.6 m below the surrounding ground level. The well utilises a surface pump which is located within the pumping station. The well has a dip pipe (approximately 4 m long down the well casing) that has a foot valve located at its base. The CCC collected a sample of water from the dip pipe via an access port on the top of the well head and they reported that no obvious visual or odorous petroleum content was present. However, following the removal of the dip pipe from the well an oily film was noted within the annular space between the dip pipe and the well casing.

The CCC reported that further inspection of the flange joints between the dip pipe and the well casing at the base of Well No. 4 chamber revealed that a plastic sampling pipe was pinched between the flanges, thus preventing a water tight seal. According to the CCC the condition of the gasket between the two flange joints suggested that it was not able to provide an effective seal.

Petroleum hydrocarbons were noted floating on water present within the base of the well head chamber of Well No. 4 and further examination showed that the flange joint at the chamber base was not water tight, thus allowing petroleum residues to enter the well casing and into the water supply. These pathways (leaking fuel line and/or broken stormwater pipe) could have been contributing petroleum residues to the underlying water table over a long period.

All seals relating to Well No. 4 and between this well and the pumping station have been replaced and the well head chamber and dip pipe have been steam cleaned and disinfected. The CCC is instigating a programme of introducing oil interceptors at pumping stations where the likelihood of contamination of stormwater systems and/or groundwater exists. Recent sampling of groundwater from Well No. 4 and also from the remaining on-site supply wells has shown non-detectable concentrations of petroleum hydrocarbon concentrations and as such the site has been re-commissioned.

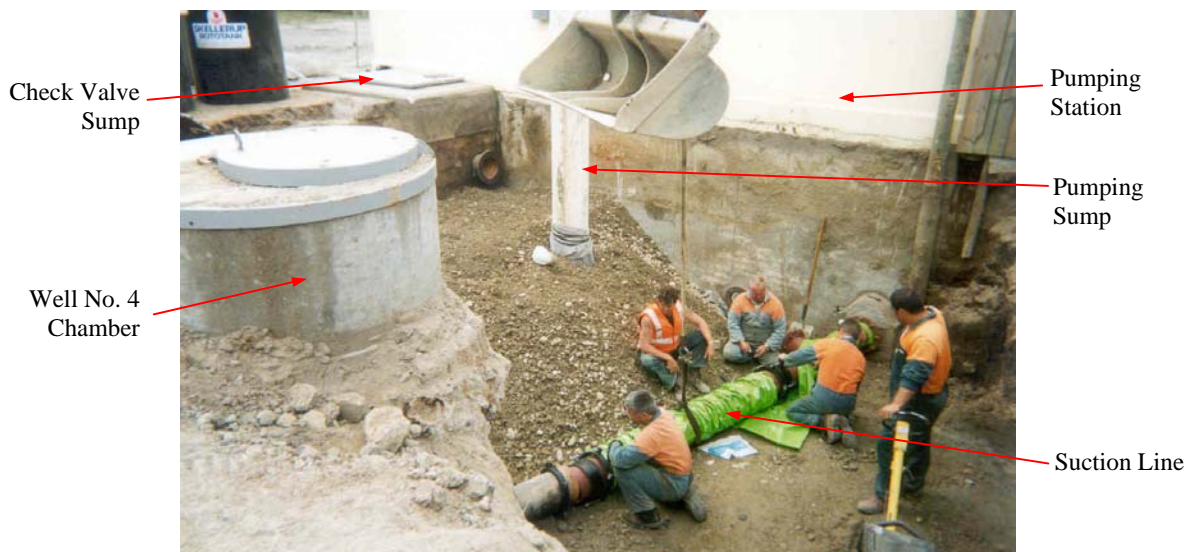
*Photograph 2: Excavation to Rear of Pumping Station*

The excavation extended between the rear of the pump building, the check valve chamber and Well No. 4. During the excavation works, under the supervision of PDP, petroleum affected soils were noted up to a depth of around 3 m below ground level. The suction pipe between Well No. 4 and the pumping station was exposed

with the invert depth of the pipe occurring at around 2.2 m below ground level (diameter 250 mm). The soils surrounding the pipe had a petroleum odour.

Black, degraded fuel was noted seeping from the base of the building foundations, at around 3 m depth, at the rear of the pumping station and into the base of the excavation. All petroleum affected soils from the excavation were carted to a Christchurch remediation facility. However, as indicated by the degraded fuel observed seeping from beneath the pumping station, petroleum hydrocarbon affected soils remain beneath the site, under the building foundations.

A small submersible pump was placed into the base of the excavation and the fuel/groundwater mixture was removed into three 1,000 L tanks, which were interconnected with submerged outlets to operate as a simple oil/water separator. The discharge from the third tank entered the site's reticulated stormwater system. No obvious sheening or odour was noted on the discharge water entering the stormwater system, indicating that the oil-water separator was operating successfully. During a site inspection undertaken on 2 April 2003 a layer of black product with a thickness of around 30 mm was present within the first 1,000 L tank of the oil separator system. The product had an odour similar to that of diesel.

Following the removal of petroleum affected soils from within the excavation to the rear of the pumping station a 400 mm diameter PVC pipe with overlapping diagonally cut slots was installed to a depth of around 3.9 m below ground level. The immediate area surrounding the slotted section of the pipe was backfilled with clean gravels which were underlain and overlain by filter cloth, whilst the remaining excavation was backfilled with sandy gravels.

It should be noted that as a prudent measure all seals along the suction pipe joints were replaced before the pipe was reconnected and the excavation backfilled.

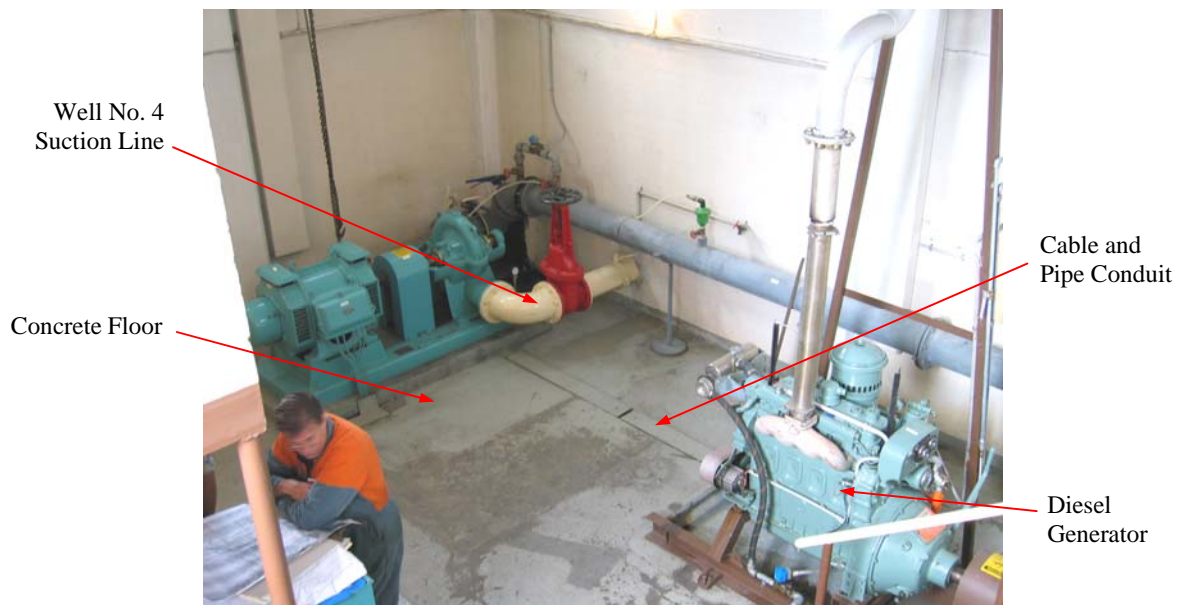
*Photograph 3: Inside Pumping Station*

Clear separate phase product with a thickness of around 20 mm was observed within a small concrete sump located within the north-western corner of the pumping station. The CCC surmised that the source of the product might have been as a result recent maintenance and cleaning of a diesel engine within the building. A sample of the product (sample ref. 'Pump House Sump') was collected into a sample bottle for laboratory identification.

Any water that collects in the sump within the station gets pumped to a ground level sump at the front of the building and then is discharged to the reticulated stormwater system. The fuel noted in this station sump had been inadvertently pumped to the reticulated stormwater system, although it was not known over what time frame this had occurred. During the investigation works by CCC it was found that the stormwater pipes adjacent to the ground level sump were broken thus providing a route for hydrocarbon migration towards the water table.

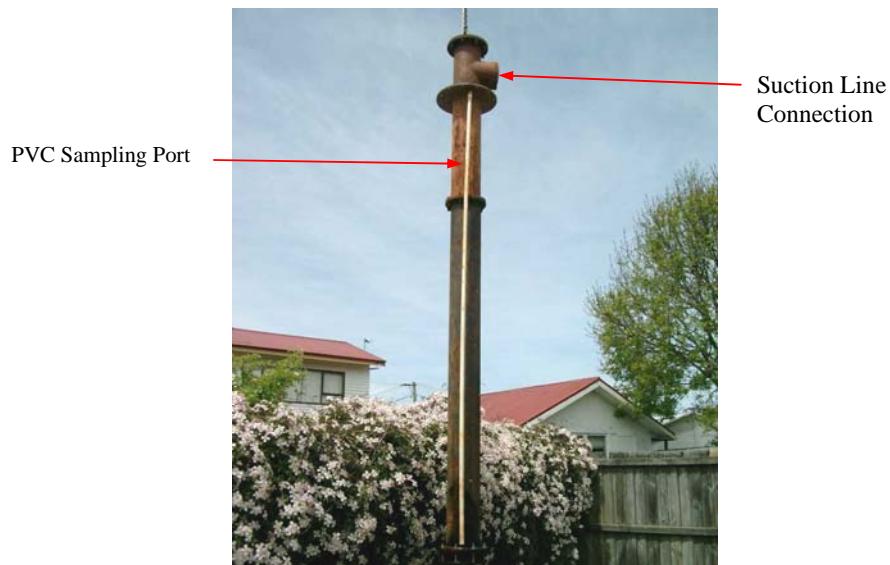
*Photograph 5: Reinstallation of Dip Pipe into Well No. 4 Casing*

During September, October and November 2003 the CCC undertook clean-up works of the affected Well No. 4 so that it could be brought back into service. The flange joint at the base of the well casing was cleaned and new seals fitted. The dip pipe and well head casing were cleaned with a steam cleaner. Following the reinstallation of the dip pipe the well and the suction line between the well head and pump station were chlorinated. Following a 24 hour period of chlorination a lay flat hose was connected to the recently installed pipework that allowed isolation of the groundwater abstracted from Well No. 4 following pumping.

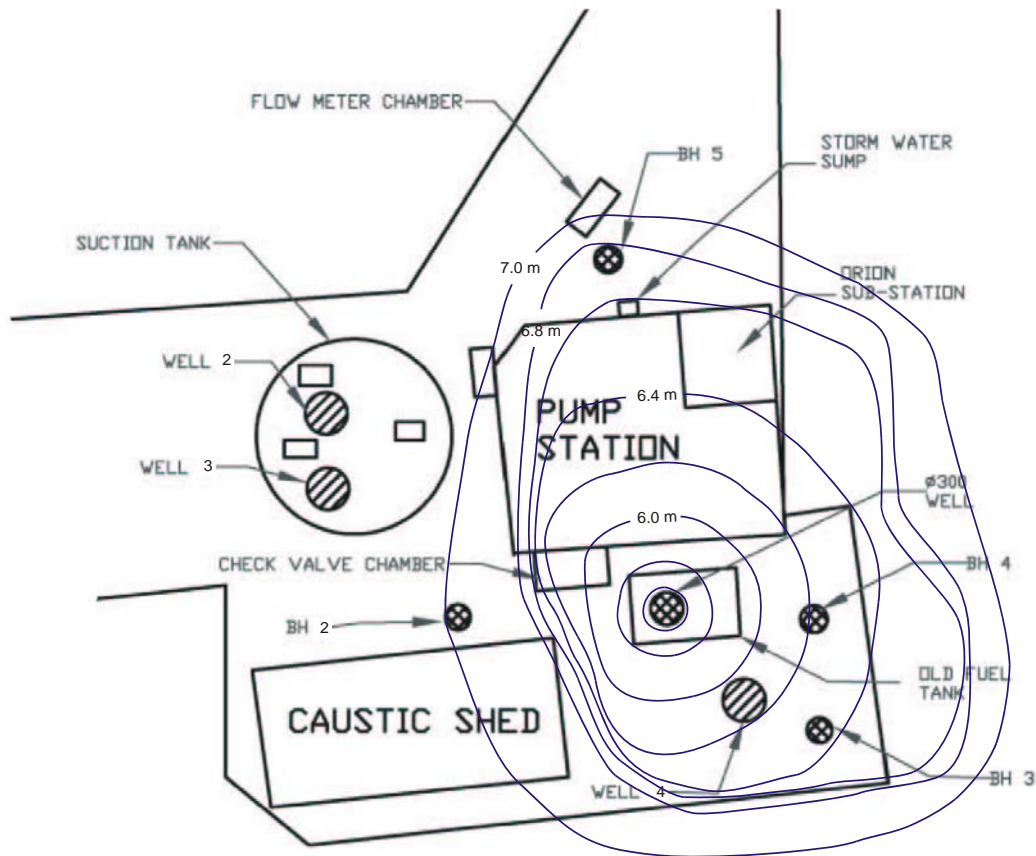
Figure 3: Approximate Groundwater Level Contours After 100 Hours Pumping at Pumping Sump

After conducting the measured pump test over an approximate 100 hour period the pump remained switched on to continue to remove the water/product from the pumping sump whilst maintaining the cone of depression. A final measuring round was undertaken on 19 June 2003 when the pump was turned off. The water level within the pumping sump had reduced a further 16 mm, with further reductions also measured in BH2 (41 mm), BH3 (114 mm) and BH5 (4 mm). The water level within BH1 and BH4 had risen by 4 mm and 87 mm respectively. The water levels in Well No. 4 and the suction tank continued to show fluctuating water levels suggesting that they are not directly hydraulically connected to the surface unconfined water table.
