# SBR RETROFIT AFTER MIDWINTER LINER RUPTURE

*Diana Kim, Craig Mountfort and Azam Khan  
Pattle Delamore Partners Limited (PDP), Auckland, New Zealand*

## **ABSTRACT**

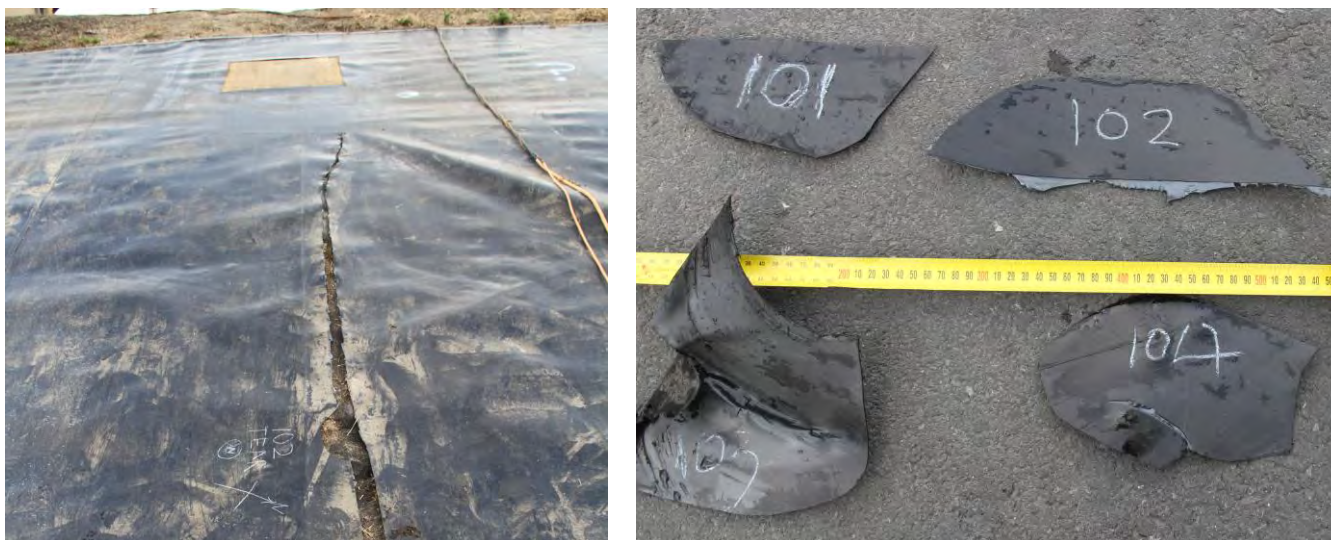
Photographs 1 & 2: Liner showing tear line, detailed damage of various areas and testing area

Within one week of operation, the site discovered that the liner had ripped near one of the earlier damaged holes and a large part of the liner was floating near the surface. The second failure that had occurred within a week was unexpected.

weld locations and the progression of failure continued for around 15 metres (lineal length) up the internal wall. This failure certainly raised the doubt on the reliability of the remaining seam welds.

An independent laboratory testing of the liner was initiated and two pieces of liner were cut from the SBR. One of these pieces was the exposed area above the top water level and the other piece was from an area that was always submerged. The testing was undertaken for stress crack resistance for geomembranes (ASTM D 5397), oxidative induction time (OIT) (ASTM D 3895) and high pressure oxidative induction time (HPOIT) (ASTM D 5885). While the test results showed that the liner had good stress crack resistance, the low OIT and HPOIT values (as shown in Table 1) showed that the anti-oxidant properties had been substantially depleted indicating that the HDPE membrane was at the end of its serviceable life.

Although the HDPE liners in New Zealand are generally provided with a 20-year serviceable life guarantee, the results were slightly surprising with OIT reducing to the extent that it had. The life of the liner was then 15 years.

It has been noted that the service life of HDPE membranes is essentially determined by the slow loss of stabilisers due to migration (Rowe *et al*, 2003). The oxidation starts only after the depletion of antioxidants and then quickly leads to brittleness of the membrane. It is generally accepted that oxidative degradation of HDPE geomembranes is not a relevant factor with regard to normal geotechnical applications, in which service lives of around 30–50 years are expected and repair work is possible (Mueller & Jakob, 2003). However, the OIT values for the exposed above top water line sample was very low, showing that a large amount of sunlight related oxidation had occurred over the years and that antioxidants were almost completely consumed. This could have resulted in the liner being brittle and unreliable for continued service after repair.

The liner tear and the area of liner utilised for testing is shown in Photograph 1. The mechanical damage could be seen in the sections cut from the liner. Given that the stress crack resistance was still high, the tear shows the enormous amount of stresses put on the liner where a mechanical score line was present that propagated the failure.

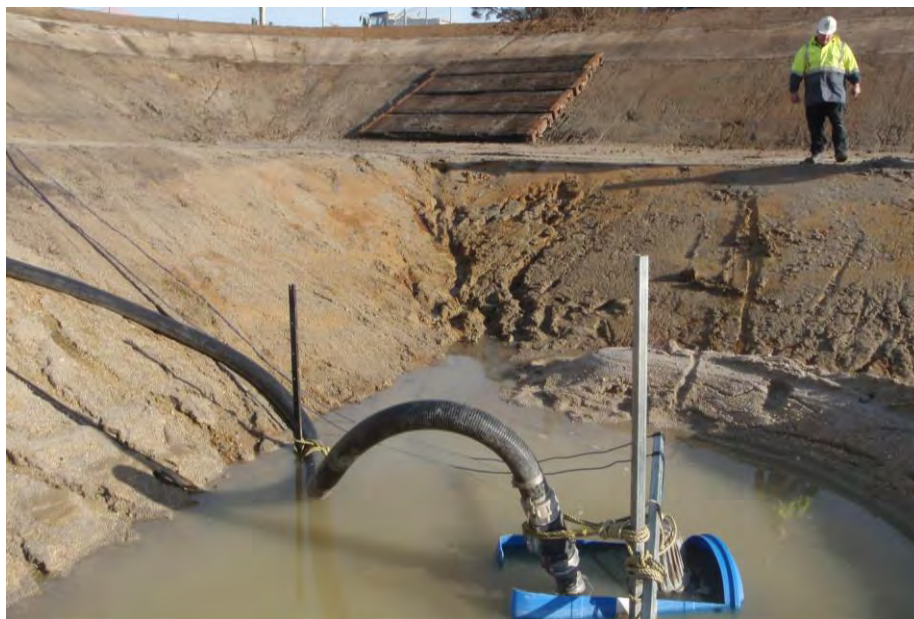
The wet weather conditions generated increased groundwater inflow into the empty lagoon and in some cases soft spots formed in areas with increased permeability. A slight gradient across the lagoon base allowed for pooling in the lowest northwest corner of the lagoon. A submersible pump was operated via a duckfoot float system to automatically dewater the lagoon. However, due to shifting sands from the original subgrade the temporary wet well regularly became inundated requiring continual maintenance and manual operation of the pump to remove accumulated groundwater.

*Photograph 3: Dewatering pump working in the low corner of the lagoon base*

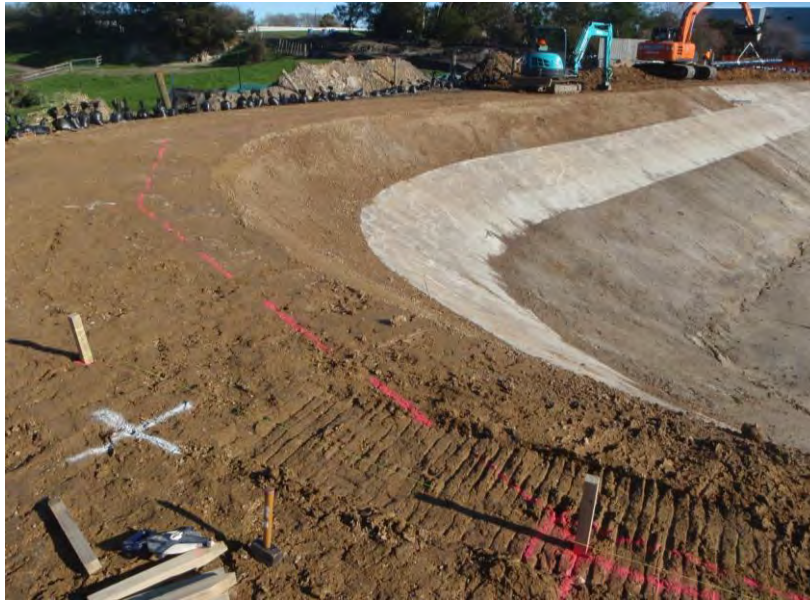
The anchor trench was designed to be 500 mm from the crest of the embankment. The photograph below shows the design co-ordinates (white crosses) and onsite mark-up (pink dashed lines) of the start of the anchor trench. The design had been based on a survey completed at the beginning of the project and embankment levels had changed somewhat significantly after that.

It was decided on site that some parts of the lagoon would have a greater separation distance than 500 mm between the crest and the start of the anchor trench. These parts were particularly soft after multiple rain events. Some parts were also stripped more than other parts to dispose of unsuitable material and were filled with clay. The increased separation distance between the anchor trench and internal slope was employed to increase the soil shear strength and ensure that this critical part of the embankment would not slump after the installation was complete.

*Photograph 4: Difference between the anchor trench design done in-house and on site*

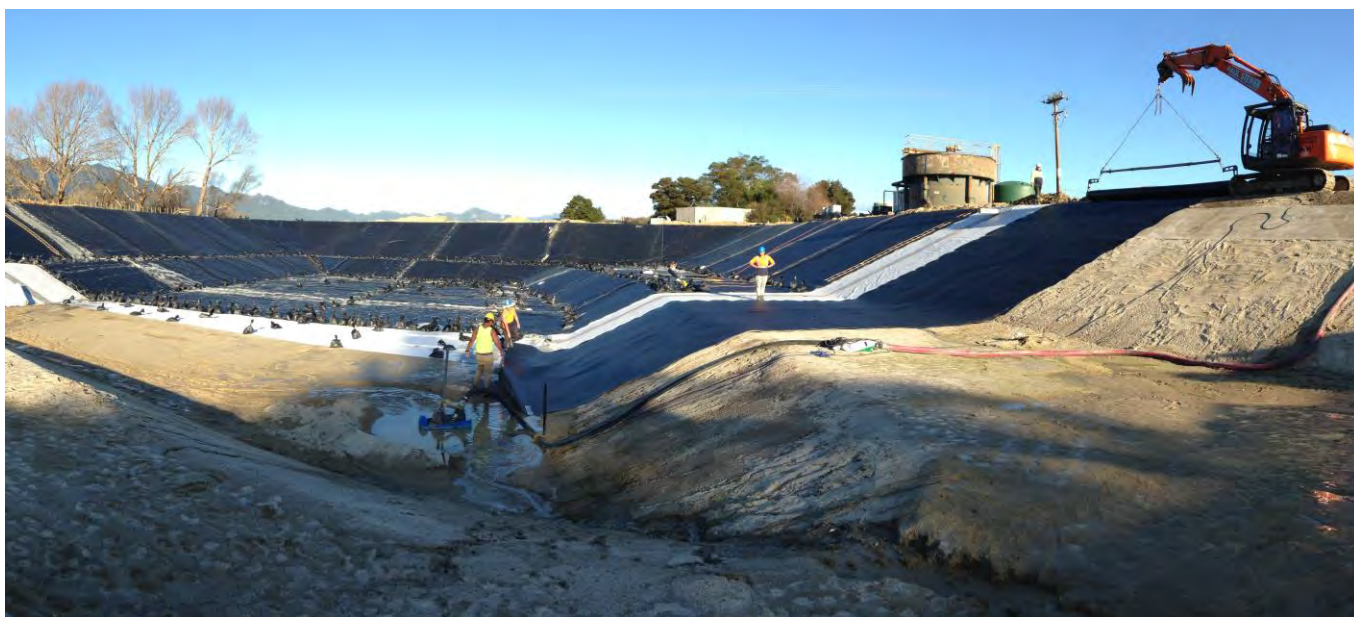
*Photograph 5: Relining of the SBR underway*

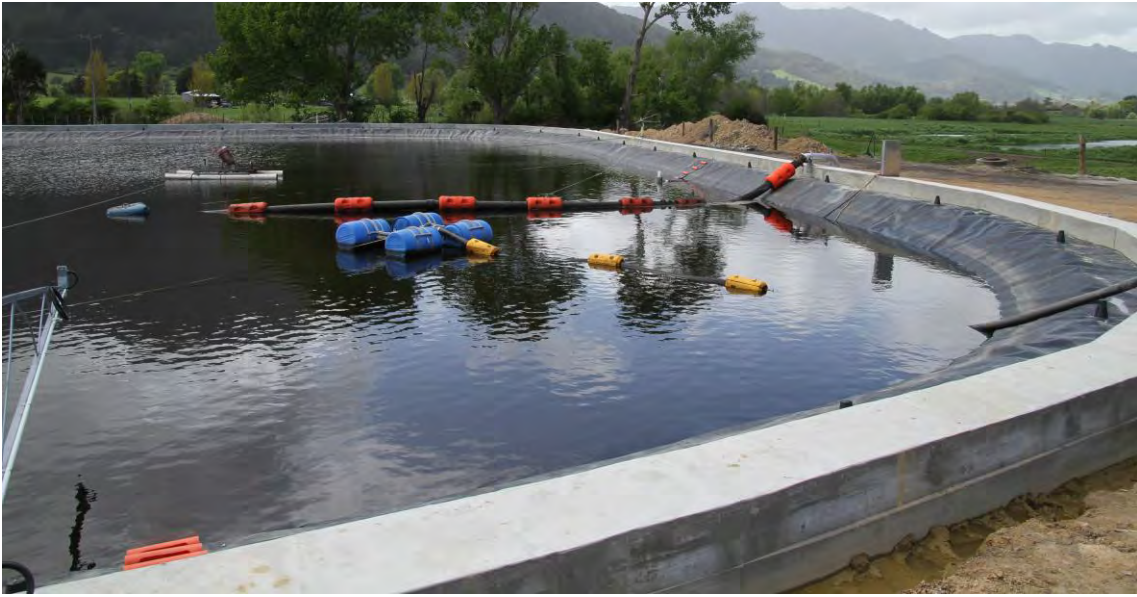
The completed anchor trench works and the aerators placement, with decant pump and outlet pipes are shown in Photograph 6.

*Photograph 6: Completed Relined SBR in Normal Operation*
