# PETROLEUM HYDROCARBON CONTAMINATION INCIDENT AT CHRISTCHURCH CITY COUNCIL GROUNDWATER PUMPING STATION

*G. Knogle; Pattle Delamore Partners Ltd  
A. Beard, B. Henderson; Christchurch City Council*

## ABSTRACT

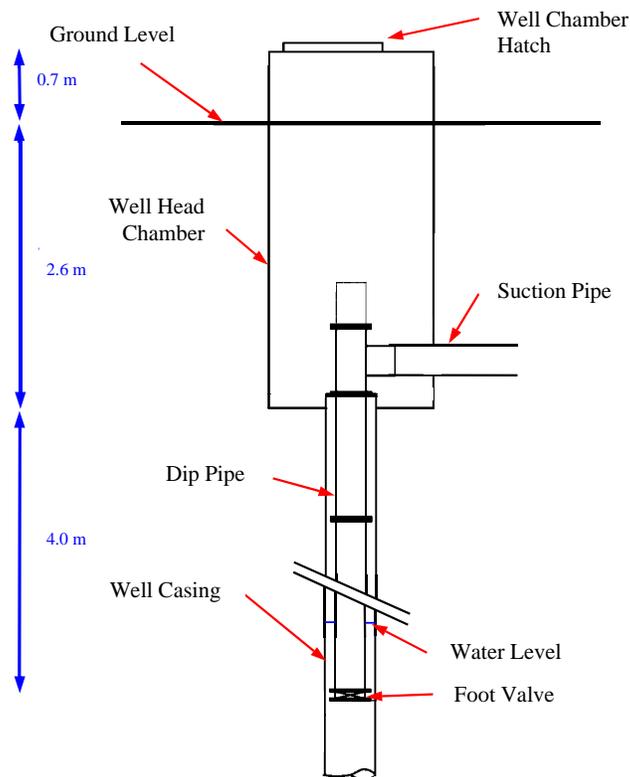
Figure 2: Schematic Diagram of Well No. 4

An inspection by CCC representatives at the Auburn Ave pumping station on 10 March revealed the presence of separate phase diesel with a thickness of up to 0.3 m floating on water within a check valve chamber, located on the south-western corner of the pumping station.

In addition, petroleum staining was noted on the walls of the concrete well head chamber of Well No. 4 to a height of around 0.3 m above the chamber base and a thin layer of diesel was noted floating on water present at

the base. The base of the well head chamber of Well No. 4 is around 2.6 m below the surrounding ground level. The well utilises a surface pump which is located within the pumping station. The well has a dip pipe (approximately 4 m long down the well casing) that has a foot valve located at its base. The CCC collected a sample of water from the dip pipe via an access port on the top of the well head and they reported that no obvious visual or odorous petroleum content was present. However, following the removal of the dip pipe from the well an oily film was noted within the annular space between the dip pipe and the well casing.

The CCC reported that further inspection of the flange joints between the dip pipe and the well casing at the base of Well No. 4 chamber revealed that a plastic sampling pipe was pinched between the flanges, thus preventing a water tight seal. According to the CCC the condition of the gasket between the two flange joints suggested that it was not able to provide an effective seal.

Petroleum hydrocarbons were noted floating on water present within the base of the well head chamber of Well No. 4 and further examination showed that the flange joint at the chamber base was not water tight, thus allowing petroleum residues to enter the well casing and into the water supply. These pathways (leaking fuel line and/or broken stormwater pipe) could have been contributing petroleum residues to the underlying water table over a long period.

All seals relating to Well No. 4 and between this well and the pumping station have been replaced and the well head chamber and dip pipe have been steam cleaned and disinfected. The CCC is instigating a programme of introducing oil interceptors at pumping stations where the likelihood of contamination of stormwater systems and/or groundwater exists. Recent sampling of groundwater from Well No. 4 and also from the remaining on-site supply wells has shown non-detectable concentrations of petroleum hydrocarbon concentrations and as such the site has been re-commissioned.

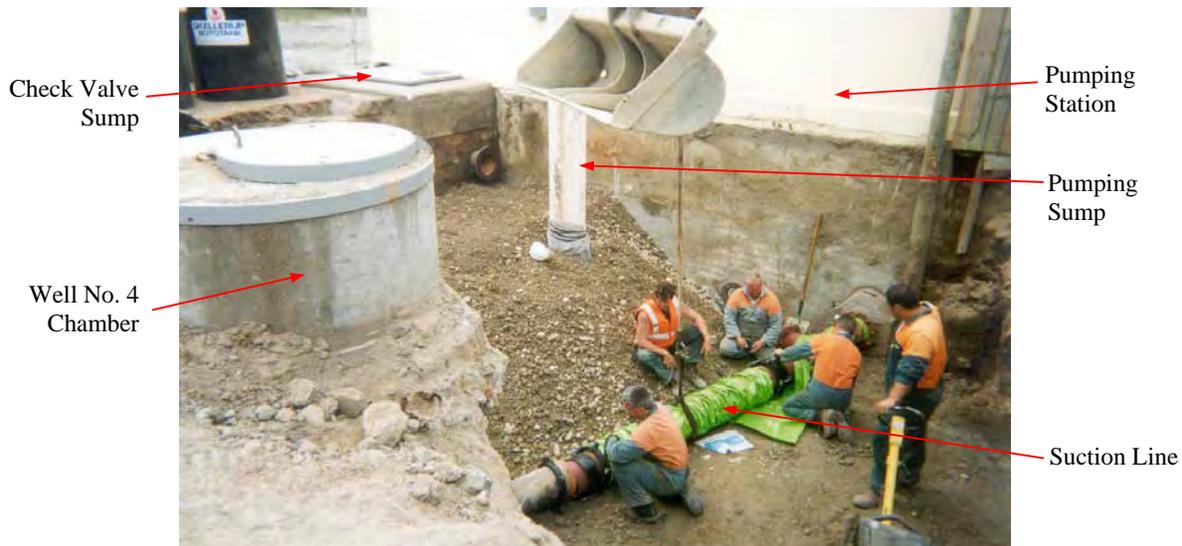
*Photograph 2: Excavation to Rear of Pumping Station*

The excavation extended between the rear of the pump building, the check valve chamber and Well No. 4. During the excavation works, under the supervision of PDP, petroleum affected soils were noted up to a depth of around 3 m below ground level. The suction pipe between Well No. 4 and the pumping station was exposed

with the invert depth of the pipe occurring at around 2.2 m below ground level (diameter 250 mm). The soils surrounding the pipe had a petroleum odour.

Black, degraded fuel was noted seeping from the base of the building foundations, at around 3 m depth, at the rear of the pumping station and into the base of the excavation. All petroleum affected soils from the excavation were carted to a Christchurch remediation facility. However, as indicated by the degraded fuel observed seeping from beneath the pumping station, petroleum hydrocarbon affected soils remain beneath the site, under the building foundations.

Following the removal of petroleum affected soils from within the excavation to the rear of the pumping station a 400 mm diameter PVC pipe with overlapping diagonally cut slots was installed to a depth of around 3.9 m below ground level. The immediate area surrounding the slotted section of the pipe was backfilled with clean gravels which were underlain and overlain by filter cloth, whilst the remaining excavation was backfilled with sandy gravels.

It should be noted that as a prudent measure all seals along the suction pipe joints were replaced before the pipe was reconnected and the excavation backfilled.

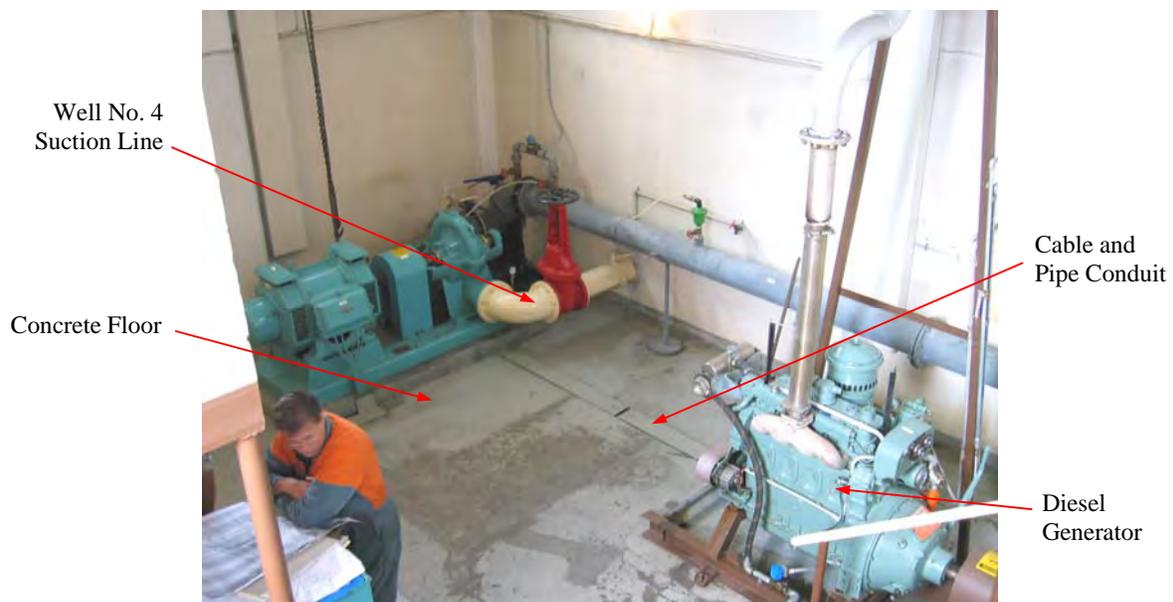
*Photograph 3: Inside Pumping Station*

Clear separate phase product with a thickness of around 20 mm was observed within a small concrete sump located within the north-western corner of the pumping station. The CCC surmised that the source of the product might have been as a result recent maintenance and cleaning of a diesel engine within the building. A sample of the product (sample ref. 'Pump House Sump') was collected into a sample bottle for laboratory identification.

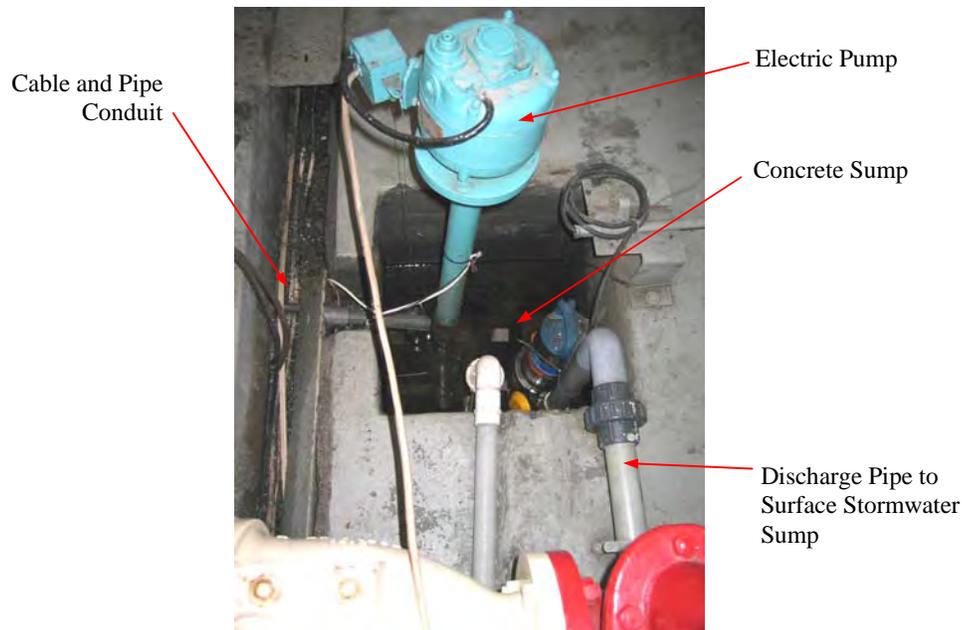
*Photograph 4: Sump Inside Pumping Station*

Any water that collects in the sump within the station gets pumped to a ground level sump at the front of the building and then is discharged to the reticulated stormwater system. The fuel noted in this station sump had been inadvertently pumped to the reticulated stormwater system, although it was not known over what time frame this had occurred. During the investigation works by CCC it was found that the stormwater pipes adjacent to the ground level sump were broken thus providing a route for hydrocarbon migration towards the water table.

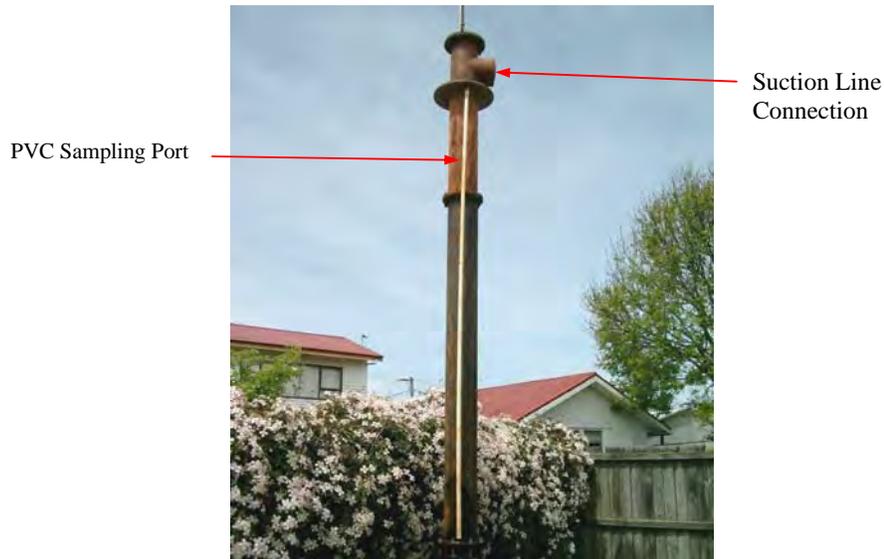
*Photograph 5: Reinstallation of Dip Pipe into Well No. 4 Casing*

During September, October and November 2003 the CCC undertook clean-up works of the affected Well No. 4 so that it could be brought back into service. The flange joint at the base of the well casing was cleaned and new seals fitted. The dip pipe and well head casing were cleaned with a steam cleaner. Following the reinstallation of the dip pipe the well and the suction line between the well head and pump station were chlorinated. Following a 24 hour period of chlorination a lay flat hose was connected to the recently installed pipework that allowed isolation of the groundwater abstracted from Well No. 4 following pumping.

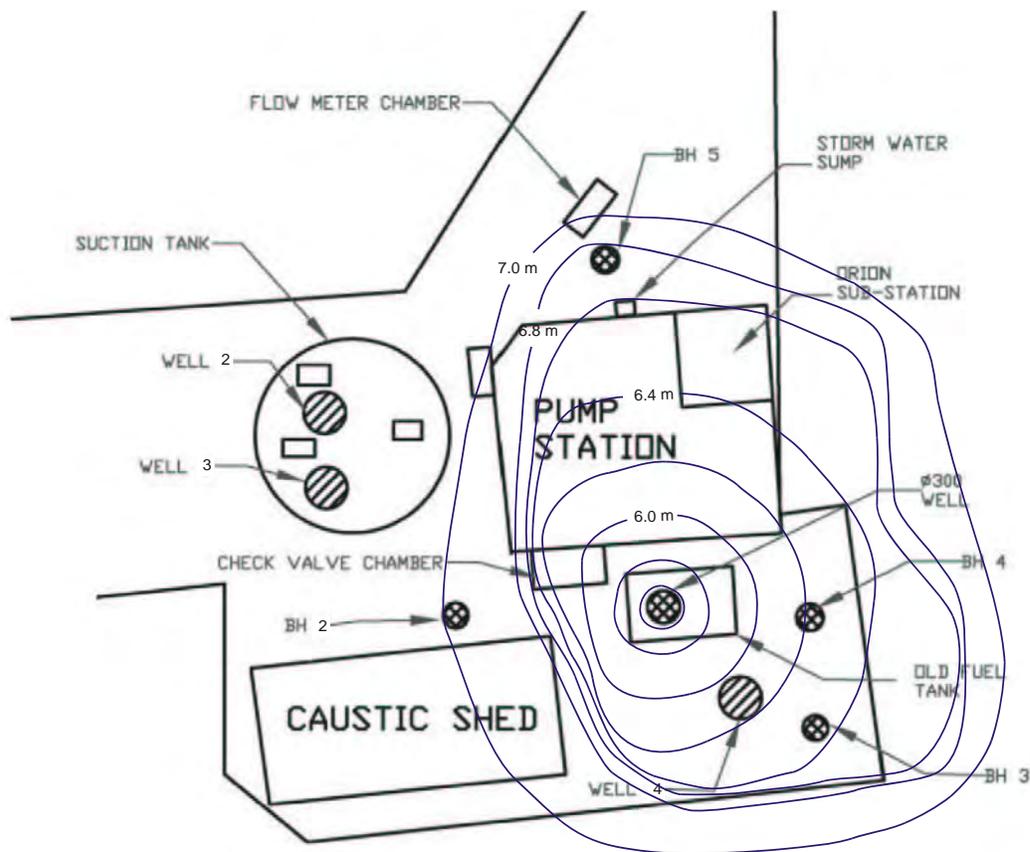
Figure 3: Approximate Groundwater Level Contours After 100 Hours Pumping at Pumping Sump

After 7.5 hours of relatively constant pumping the water level in the pumping sump was drawn down to the pump intake and as such the pumping rate started to slow down. This is the point at which all of the readily available water in the more permeable backfill of the excavation and foundations had been removed and the pumping rate was now representative of the natural lower permeability soils beneath the site. Approximately 15 minutes after the water level was drawn to the pump intake the flow rate had dropped from 0.5 L/s to around 0.04 L/s. After 24 hours the pump rate had decreased to around 0.016 L/s and at around 100 hours the pump rate had decreased to around 0.014 L/s.

After conducting the measured pump test over an approximate 100 hour period the pump remained switched on to continue to remove the water/product from the pumping sump whilst maintaining the cone of depression. A final measuring round was undertaken on 19 June 2003 when the pump was turned off. The water level within the pumping sump had reduced a further 16 mm, with further reductions also measured in BH2 (41 mm), BH3 (114 mm) and BH5 (4 mm). The water level within BH1 and BH4 had risen by 4 mm and 87 mm respectively. The water levels in Well No. 4 and the suction tank continued to show fluctuating water levels suggesting that they are not directly hydraulically connected to the surface unconfined water table.
