# LOSS OF SUPPORT FROM BELOW – FAILURE OF WASTEWATER TREATMENT LAGOON

*Azam Khan & Neil Crampton - Pattle Delamore Partners Ltd, Auckland*

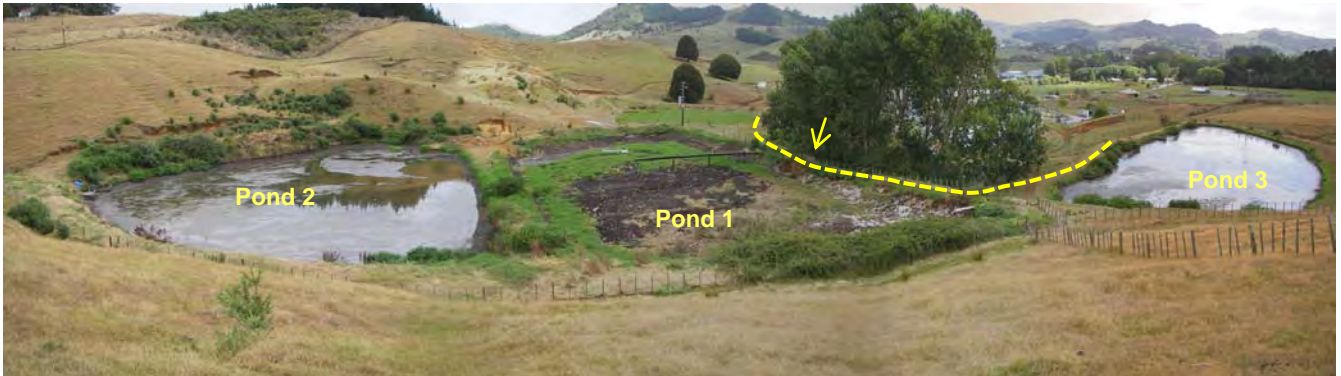
The collapse of the sinkhole was significant as all the liquid from the main anaerobic lagoon (Pond 1) drained in addition to some liquid from Pond 2 that was hydraulically connected to Pond 1. A series of photos taken post-failure show the extent of the cracking around the anaerobic lagoons.

*Photograph 2: Anaerobic Lagoon (Pond 1) showing the cracking line and scarp (arrow)*

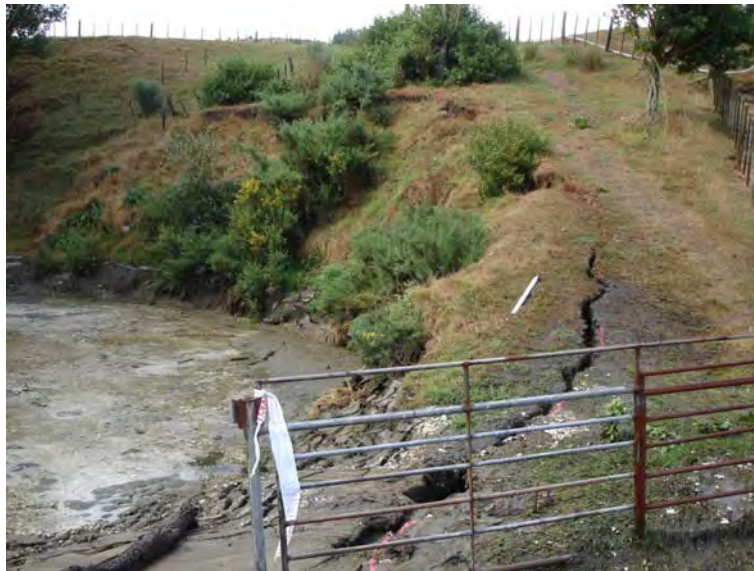
A fissure up to 1 m wide and 3 m deep formed around the southern part of the sinkhole crack system and locally between Pond 1 and 3. An example of the large fissure near the sinkhole is shown in Photo 3.

*Photograph 3: Fissure Formation near the Sinkhole*

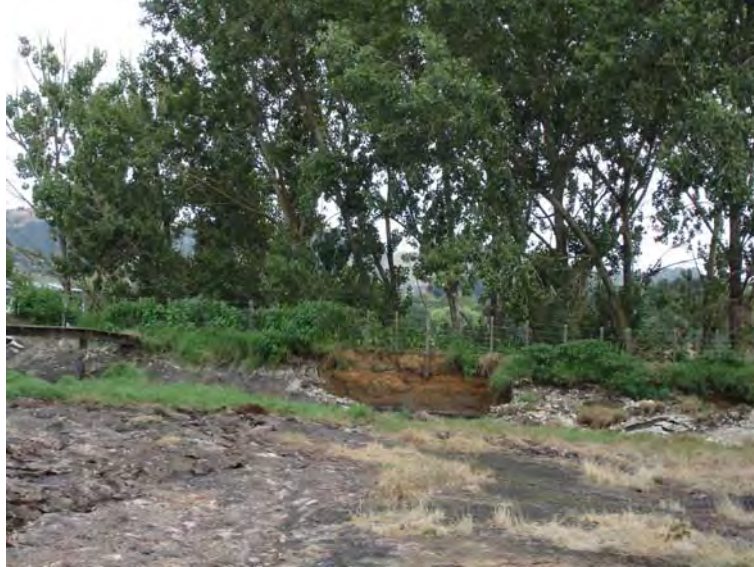
The predominant scarp that formed on the inside embankment of Pond 1 is shown in Photo 4.

*Photograph 4: Pond 1 Scarp on the inside Embankment*

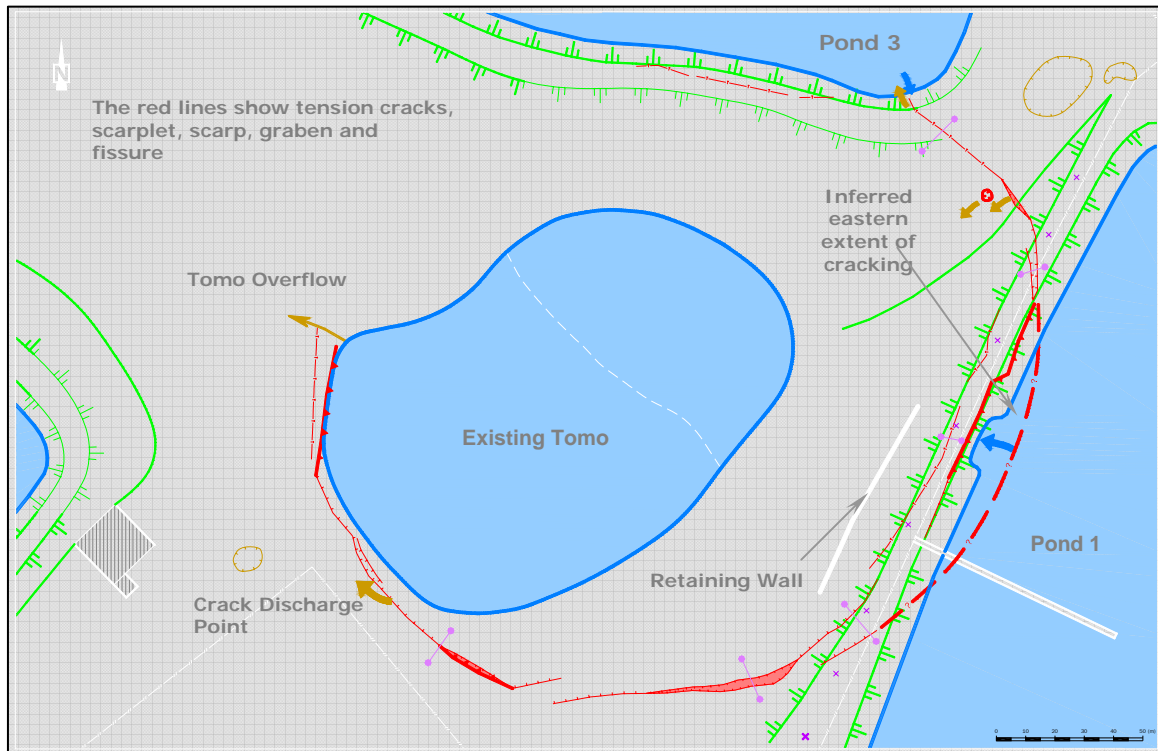
Figure 1: Failure Mapping around the Sinkhole

A detailed inspection of all failure features (mostly ground cracks) was carried out to determine the nature and extent of the failure. The failure features were marked with spray paint, surveyed and details such as crack openness and displacement were recorded. This information was then compiled onto an engineering geological map (Figure 1).

The investigations carried out indicated that once the failure occurred, the crack system, shown in Figure 1, opened progressively allowing the Pond 1 wastewater to flow south into the cracks. The wastewater flowed down and exited the fissure system near the sinkhole, discharging overland into the sinkhole as shown in Photo 3. There was also a small amount of wastewater that flowed from Pond 1 into Pond 3 and then discharged into the sinkhole through a “discharge hole” between Pond 1 and Pond 3. Wastewater from the crack system filled and over-topped the sinkhole and discharged to Mangaokewa Stream via the site’s stormwater drains. Wastewater also flowed through the base of the sinkhole into the underground tunnel system linking the sinkhole with a spring daylighting between Rangitoto Road and Mangaokewa Stream some 350 m directly south-west of the sinkhole. The water level in the sinkhole dropped slowly in the days following the failure.

Information gathered from the investigations indicated that the most likely mode of failure was expansion of the existing sinkhole due to collapse of supporting limestone into the underground tunnel system. Surface displacements indicate that the total amount of failure movement is likely to have been between 1 - 3 m. The main evidence supporting this failure mode is the oval shape of the crack system formed by the failure, its similarity to the existing sinkhole shape and its location around the existing sinkhole (Figure 1). Additional evidence was extension/opening being the principal movement component associated with the failure cracks. This suggested inward rotation (almost toppling) into the existing sinkhole cavity due to loss of support from beneath.

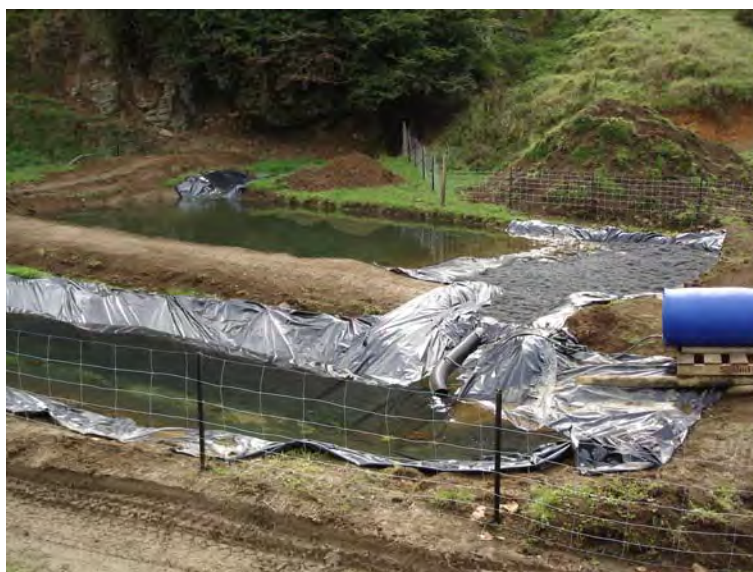
*Photograph 5: Temporary Spring Flow Treatment System*

For the first two weeks after the pond failure, from 10 March – 25 March 2007, the company intercepted all the contaminated spring water, and trucked it off site for treatment. On 25 March 2007, the company installed temporary treatment ponds at the spring site. The treatment pond system comprised a primary settling pond of approximately 50 m<sup>3</sup>, followed by a gravel filter with a volume of 12 m<sup>3</sup>, followed by a chlorine disinfection contact trench. The pond design assumes a two hour settling time based on a peak spring discharge of 10 L/s. The observed flow rate from the spring is about 1 L/s in dry weather to 10 L/s in wet weather. The design was selected at 10 L/s after observing the flow rate following a 50 mm rainfall event on 12-13 March 2007. The general layout of the settling pond, gravel filter and disinfection channel is shown in Photo 5.
