# WAIOURU SEWAGE TREATMENT PLANT UPGRADE

*Warren McKenzie, Pattle Delamore Partners Ltd (PDP)*  
*Rob Docherty, Pattle Delamore Partners Ltd (PDP)*

## ABSTRACT

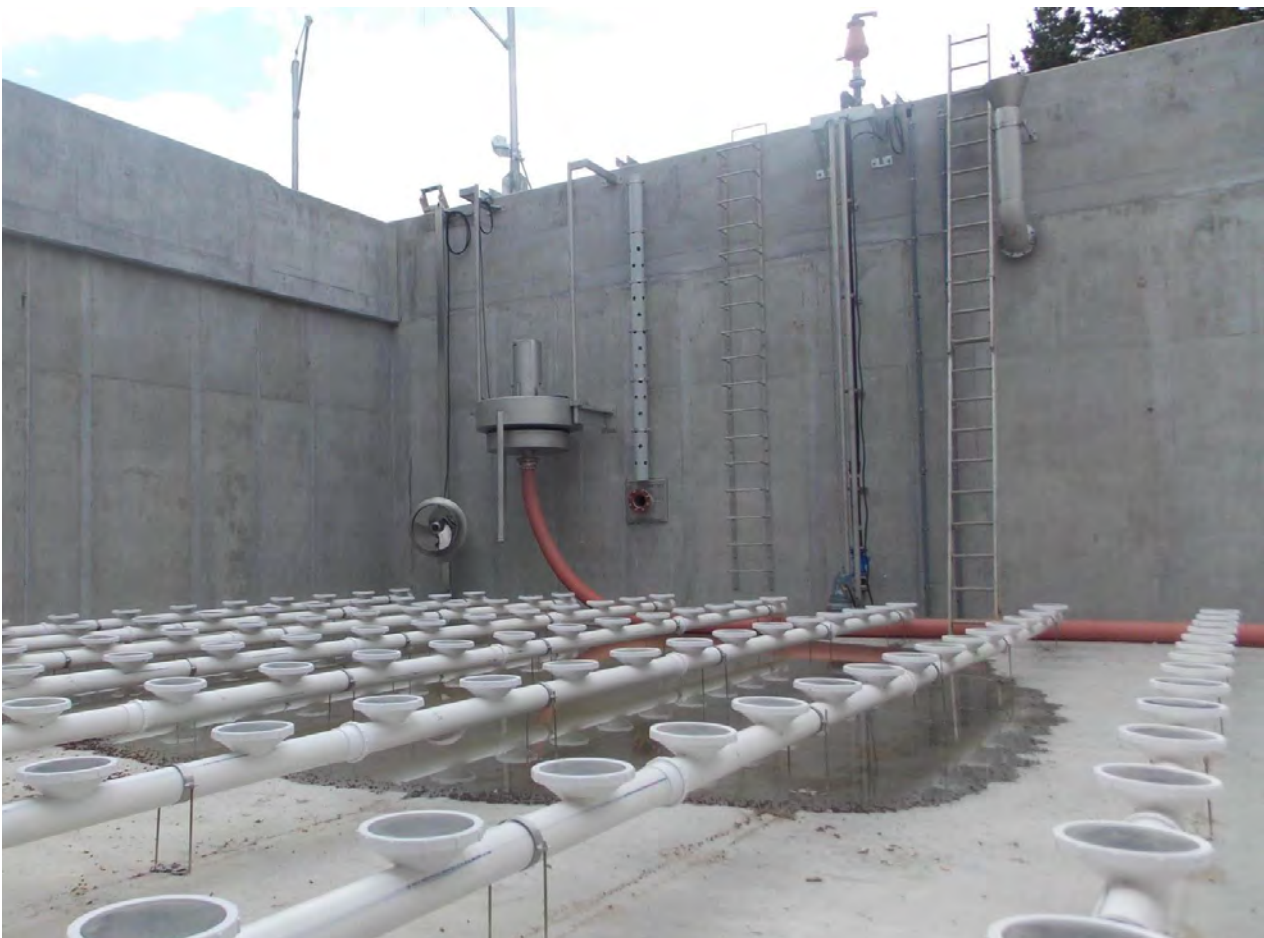
*Photograph 1: SBR Fitout*

The upgrade of the plant includes a new dual tank Sequencing Batch Reactor (SBR), Alum dosing for phosphorus removal, UV treatment, improved sludge handling facilities and the refurbishment of many of the existing treatment processes with a total CAPEX of \$3.5M. The plant discharges into the Waitangi Stream which enters the Whangaehu River a few kilometers downstream.

- Inlet works, with grit chamber and step screen
- Primary clarifier
- **SBR Lift Pumpstation with 40L/s capacity.**
- **2 x 800m<sup>3</sup> SBR tanks (400m<sup>3</sup> live volume per cycle) with diffused aeration, submersible mixers, sludge wasting pumps, floating decants and monitoring probes.**
- **Caustic dosing to increase alkalinity prior to nitrification in SBRs (alkalinity deficient wastewater).**
- **Carbon dosing to assist denitrification (due to an inadequate C:N ratio).**
- Trickling filters (2 of, working in parallel).

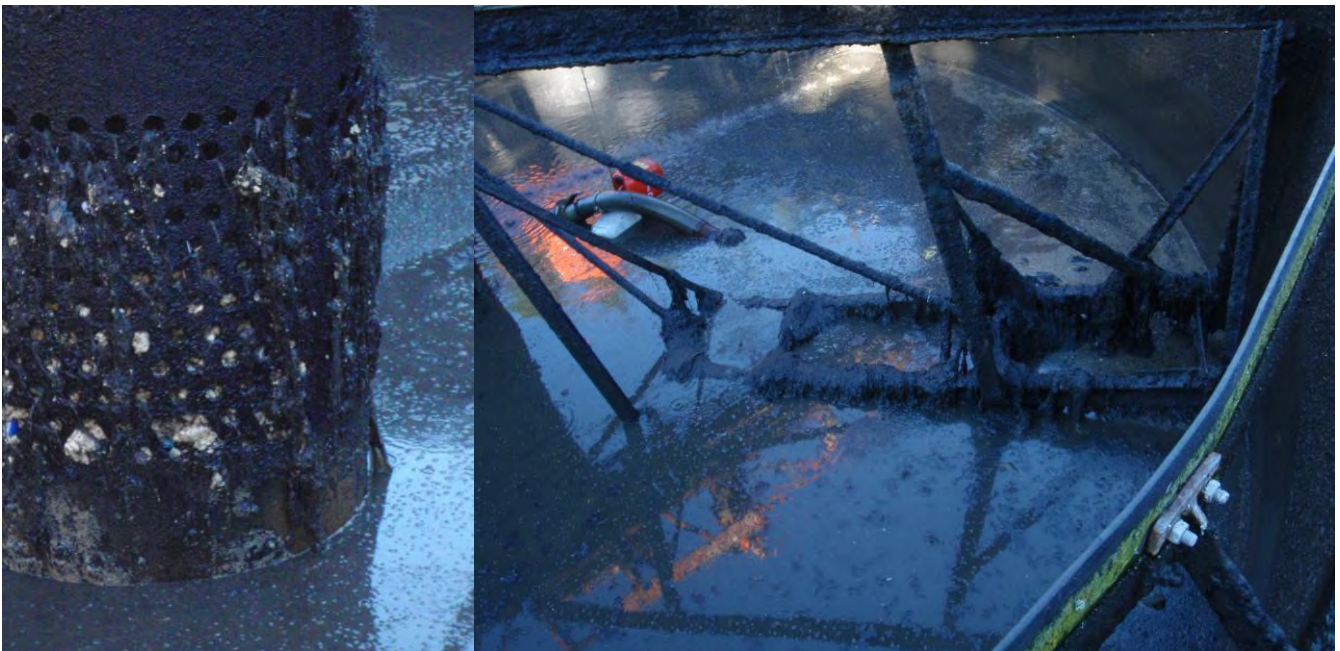
The primary clarifier was the first existing treatment process to be drained, photographs of which are shown below.

*Photograph 1: The Sludge Merry-go-round*

The primary clarifier steelwork was in a heavily deteriorated condition and a significant rebuild of the scraper mechanism and central column was required. Concrete work was, however, in very good condition for its age.

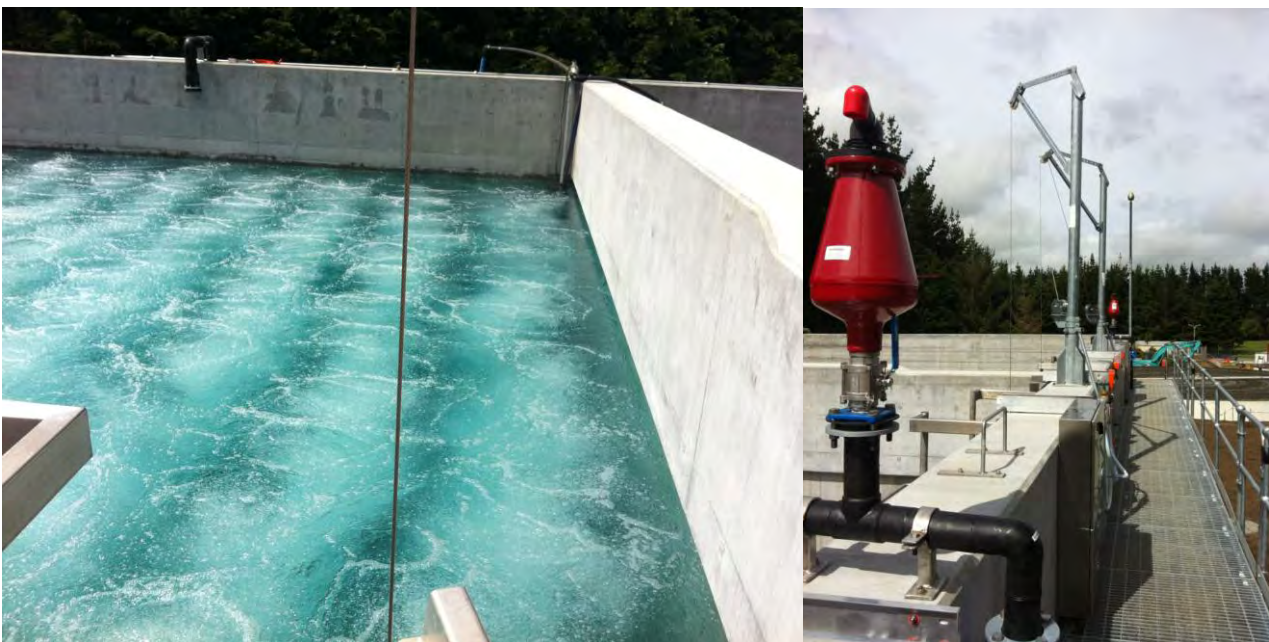
The SBR tanks were commissioned in December 2013. Each tank was filled with fresh water (for a full-scale water test) and every item of mechanical equipment was tested thoroughly prior to introducing wastewater into the tanks for the first time. As the individual tanks filled, an activated sludge seed (from Acacia Bay WWTP near Taupo) was added together with molasses as a supplementary food source. The activated sludge volumes grew quickly to target levels.

*Photograph 2: Water testing of the SBR tanks*
