**ACCOUNTING FOR THE POTENTIAL AND ACTUAL COSTS ASSOCIATED  
WITH ENVIRONMENT CANTERBURY'S PEST DEPOTS AND OTHER SITES**  
Guy Knoyle, Pattle Delamore Partners Ltd, PO Box 389, Christchurch (Tel – 03 379 3532,  
email – [guy.knoyle@pdp.co.nz](mailto:guy.knoyle@pdp.co.nz))  
Helen Davies, Environment Canterbury, PO Box 345, Christchurch (Tel – 03 365 3828,  
email – [helen.davies@ecan.govt.nz](mailto:helen.davies@ecan.govt.nz))

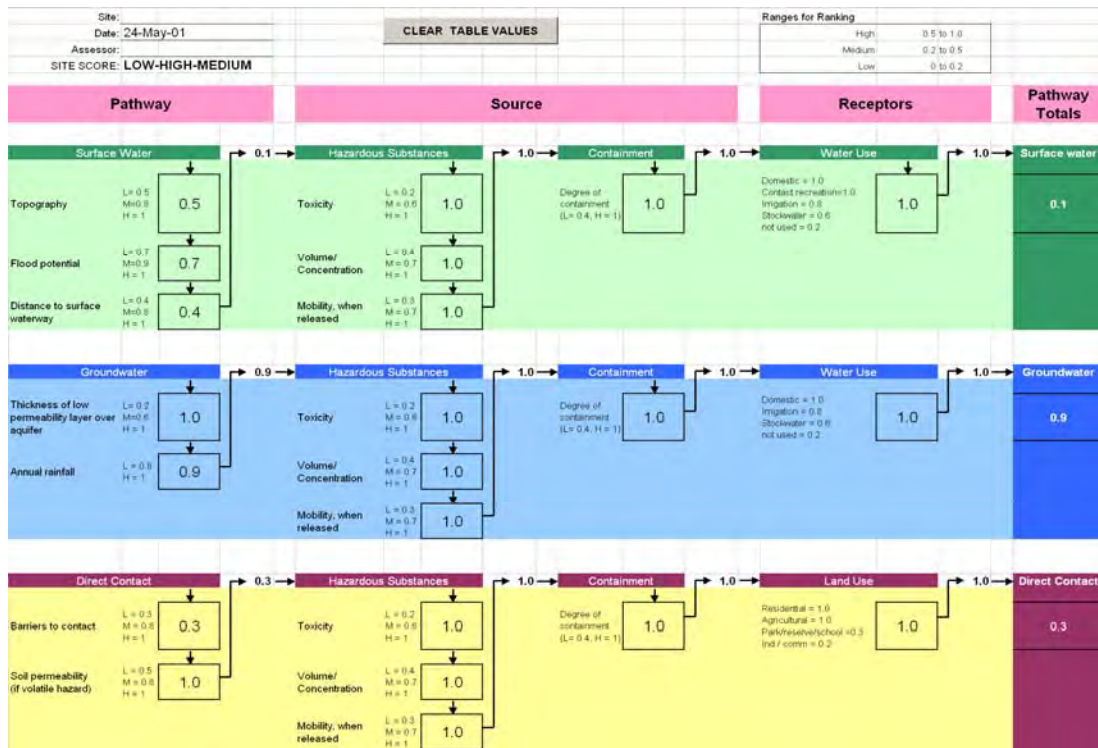
The RHAS report for each site has a scoring system for the three main pathways of concern, i.e. surface water, groundwater and direct contact (including dermal contact and inhalation). The scoring system is based on a multiplicative approach so that for each pathway a maximum score of 1.0 can be attained. A score of 1.0 is interpreted as a high environmental risk and conversely, a score of 0.1 would be considered a low risk. A score is assigned to each of the three pathways in the order “surface water rank – groundwater rank – direct contact rank”.

A worked example of a RHAS report completed for the investigation is shown below.

For this investigation some of the RHAS parameters were given constant numerical weightings, either because the parameter was considered to be generally the same for all 33 sites in the investigation, or the information was not available. For example, a conservative weighting of 1.0 (assumed high environmental risk) was used throughout the RHAS site assessments for soil permeability since strata logs suggested that the sites were underlain by permeable soils. A conservative weighting of 1.0 was also used for the volume/concentration parameter due to the wide variation in accuracy and variability of data for each site making comparative ranking inconsistent. Similarly, with regard to containment a weighting of 0.7 was used for sites where it was unknown if any discharges of contaminants into the receiving environment had occurred, but it was considered likely due to practices indicated in the site history. With regard to assessing the potential risk to groundwater systems, the depth of nearby abstraction wells was not taken into consideration, only the lateral distance from the site was assessed. This allows for the risk of shallow contaminated groundwater affecting a well due to perforations in the well casing.

Applying a RHAS evaluation for each site enabled it to be broadly categorised into one of the three groups according to its environmental risk (low, medium or high). Sites being grouped into the “high environmental risk” group could then be prioritised for further investigative works.
