# AMBERLEY FLOODS – JULY AND AUGUST 2008

*Mark Pennington, Engineer, Pattle Delamore Partners Limited*

*Jeff Melanson, Environmental Engineer, Pattle Delamore Partners Limited*

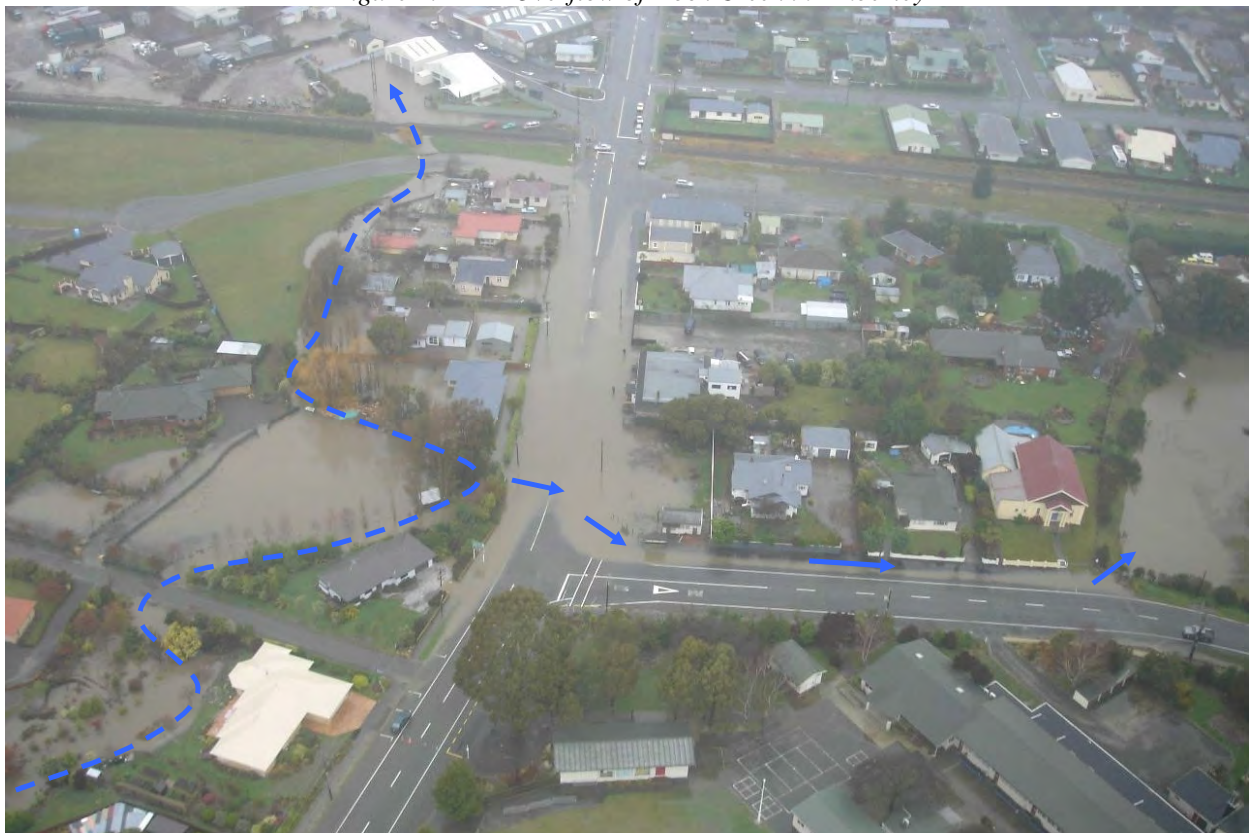
Figure 2: Overflow of Dock Creek in Amberley

Dock Creek flows in a southerly direction through the Amberley Township east of State Highway 1 and eventually discharges into the near-by Kowai River (north branch). There was significant evidence that Dock Creek was unable to cope with the flow demands placed on it during the July and August 2008 rainfall events.

Inflow to Dock Creek is controlled by a structure at the upstream end, which is supposed to regulate not only low flows but also flood flows to the creek. During times of flood this control structure can be manually manipulated to divert excess runoff directly to the Kowai River. However, the creek is able to collect considerable runoff from catchments north of Amberley that are located downstream of this control structure, as well as from the township itself. Several reaches of Dock Creek, most notably within the Amberley Township, were observed to have exceeded the channel's capacity and as a result contributed to the Amberley flooding event. Figure 2 shows one instance of many where Dock Creek spilled its banks and resulted in the flooding of near-by houses.

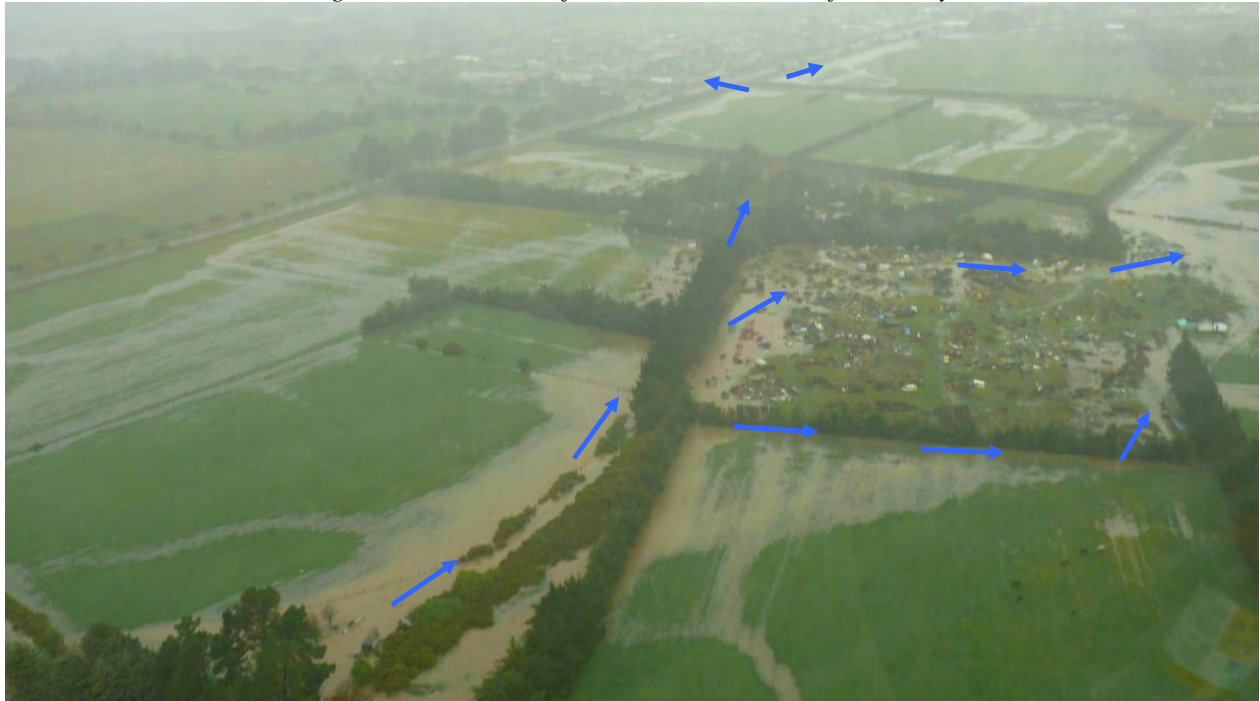
*Figure 3: Flow of Eastern Drain North of Amberley*

Figure 3 shows Eastern Drain as it flows into Amberley from the north. This figure suggests that Eastern Drain was flowing well beyond its capacity and that excess flows spilled from Eastern Drain into Dock Creek to the west (right-hand-side in Figure 3), further exacerbating flooding issues in Dock Creek.

Evidence suggests that a large contributor of flow to Eastern Drain was runoff from the large vineyard operation located immediately north of Amberley. Once these vineyards became saturated, a significant amount of runoff was generated from the area and, having no other flow path available, this runoff flowed south and into Eastern Drain. Several culverts also exist along State Highway 1 north of the Amberley Township. These culverts convey runoff from the hills east of State Highway 1 via overland flow directly into the upper reaches of Eastern Drain. In conjunction with the flow from the vineyards, it is likely that these catchments north of Amberley caused Eastern Drain to exceed its capacity well before even entering the township. There have been suggestions to the effect that in conjunction with the change in rural land use that has occurred over recent years north of Amberley, some changes to contributing catchments were also made.

During the 2008 events, Dock Creek received additional runoff via overland flow from Eastern Drain (as shown in Figure 3) that entered the main waterway downstream of the flow control structure. It has also been suggested that this structure was bypassed by other surface flows during these events, resulting in a greater inflow to the Creek than would have been allowed by the control structure design. In order to continue to limit the inflow to Dock Creek these other overland flows that contributed to the creek will need to be stopped, thereby ensuring that inflows to the creek are only controlled by the flow control structure and by locally generated runoff through Amberley. By undertaking inflow reduction works for Eastern Drain as outlined above, the likelihood of Eastern Drain causing overland flow to Dock Creek will be reduced. This is shown in Figure 8.

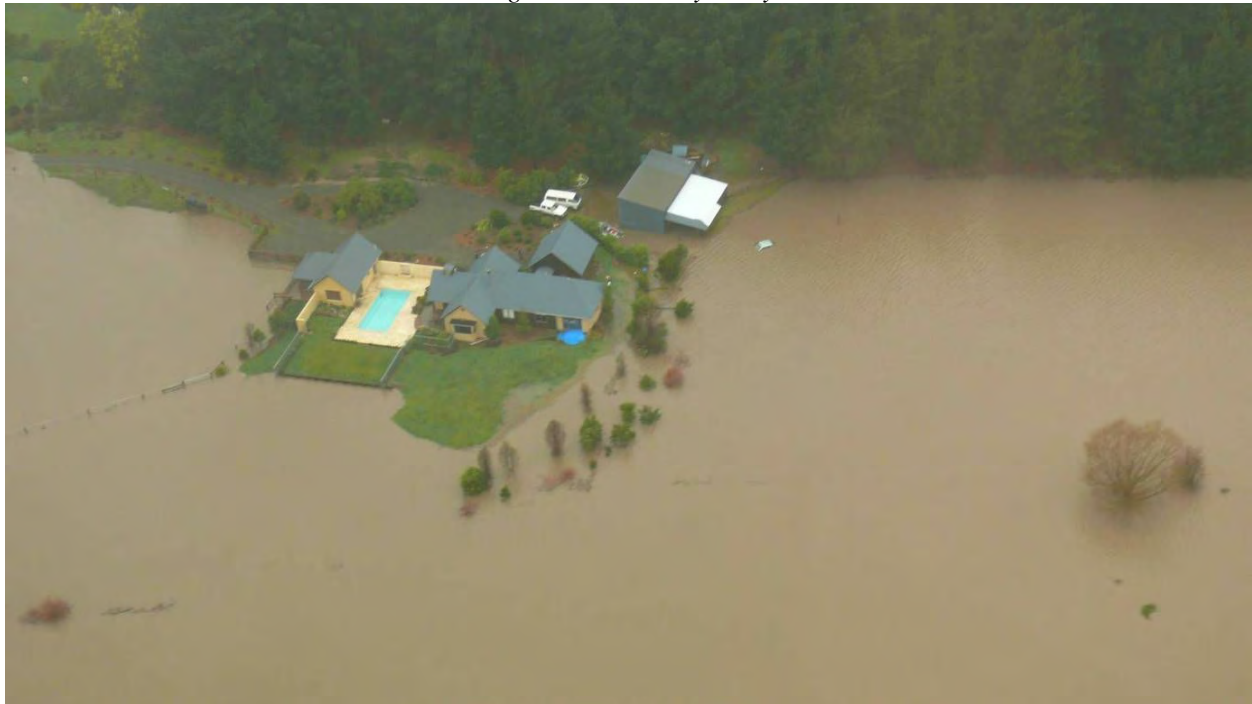
*Figure 4: Dry Gully*

During the 2008 rainfall events Dry Gully filled up substantially and was able to convey runoff towards Hursley Terrace (rural road east of Amberley Beach). A section of the so-called Dry Gully is shown in Figure 4. The upper end of this feature, immediately adjacent to State Highway 1, does not have a significant upstream contributing catchment area and appears to have excess capacity for the flows likely to be conveyed. It is possible that this is a result of construction of SH1 in that this road essentially beheads what may have been a larger catchment area prior to road construction.

Further downstream within Dry Gully there are known to be local constrictions to flood flows. The effects of these would be to cause the gully to fill to higher levels than would occur without such constrictions. It would be possible to remove such constrictions and allow for a greater conveyance capacity within this waterway. The major constraint with doing this comes at the downstream end, where runoff exits Dry Gully and runs across Hursley Terrace and enter the Amberley Beach area which has significant capacity constraints.

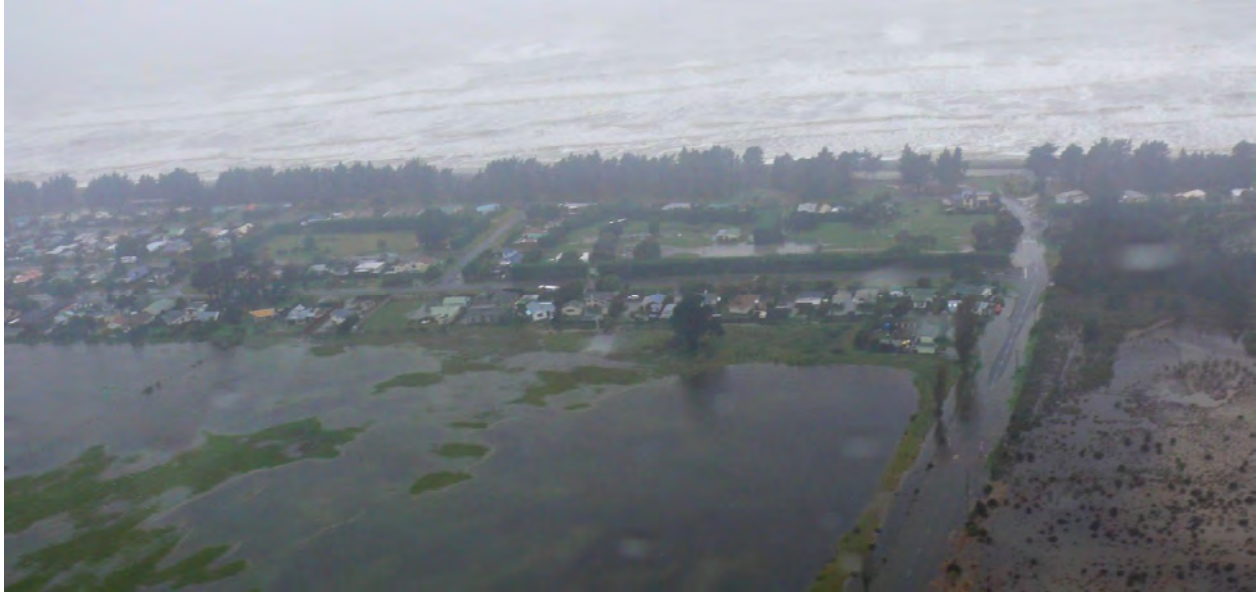
*Figure 5: Flooding of Amberley Beach and Amberley Beach Road*

Runoff from Amberley flows south-east towards Amberley Beach via Eastern Drain and Dry Gully. The 2008 storm events had an extensive impact on the Amberley Beach area. Figure 5 shows an aerial photograph of the township taken during the July 2008 event. As can be seen in Figure 5, flooding was not confined to the township alone and that areas surrounding Amberley Beach also experienced widespread flooding.

Flow from Dry Gully and other surface waterways was able to flow over Hursley Terrace and continue overland to Amberley Beach Road. Figure 6 shows stormwater from northern reaches of Dry Gully flowing over Hursley Terrace and flowing overland towards Amberley Beach. Much of the water which passed over Hursley Terrace, as well as the runoff generated further north along Amberley Beach Road contributed to a large accumulation of water at the bottom of Amberley Beach Road which can be seen in Figure 5.

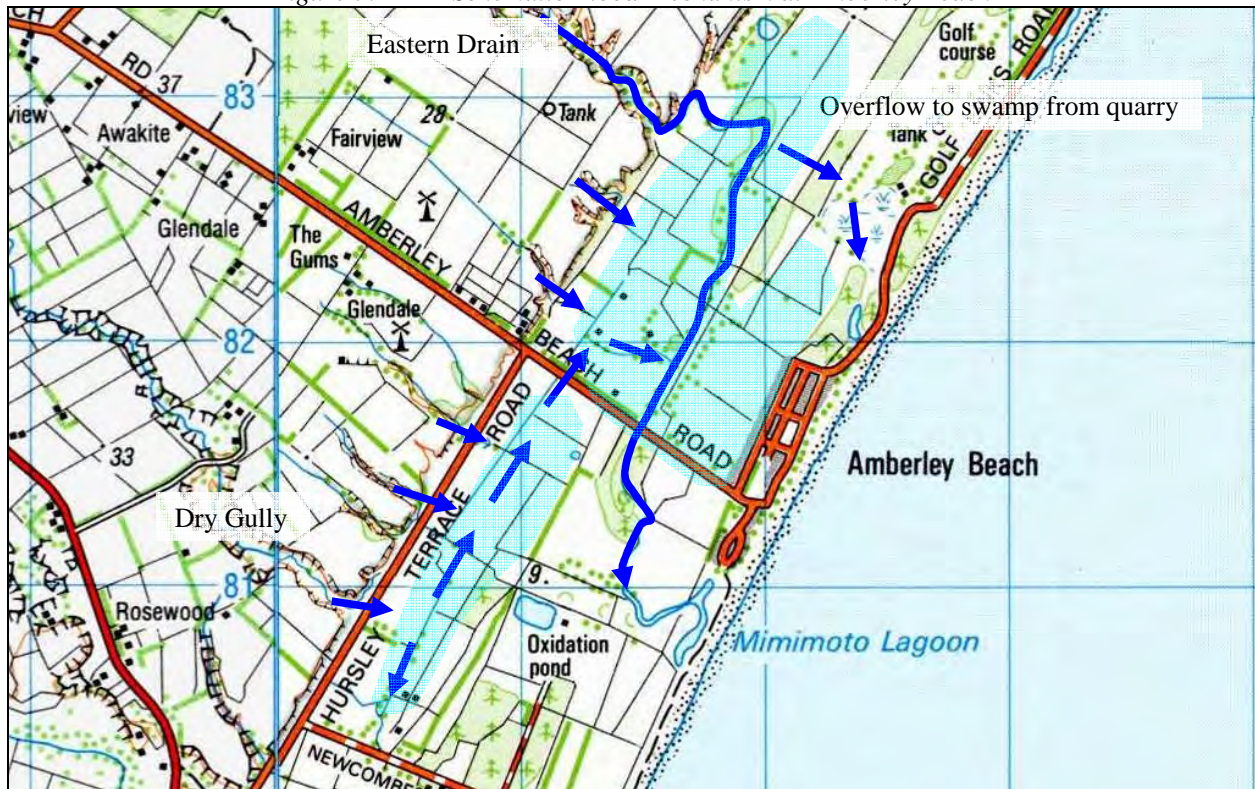
Figure 7: Schematic Flood Mechanism at Amberley Beach

A schematic plan showing the progression of flood runoff and its convergence near to and within Amberley Beach is shown in Figure 7.
