# Oamaru Bay Coastal Land Disposal – A Retrospective

## ABSTRACT

Oamaru Bay is a small beach community on the western coast of the Coromandel Peninsular. Its winter and peak summer populations are about 70 and 400 respectively. Its wastewater has been disposed of to land since a reticulated sewerage scheme was installed in 1992. Disposal is by subsurface irrigation in an area of riparian pasture land that is about one metre above and 100 metres inshore of the high tide mark.

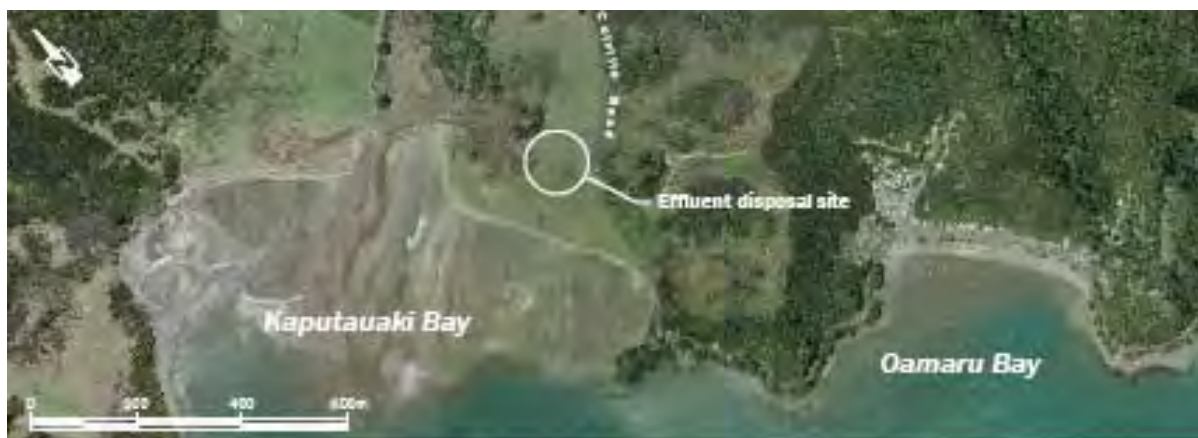
**Figure 1.** Site location.

The topographic and surface geologies of the two bays are also quite different, as is evident in Fig. 1 which also shows the markedly different areas of foreshore that are exposed at low tide.

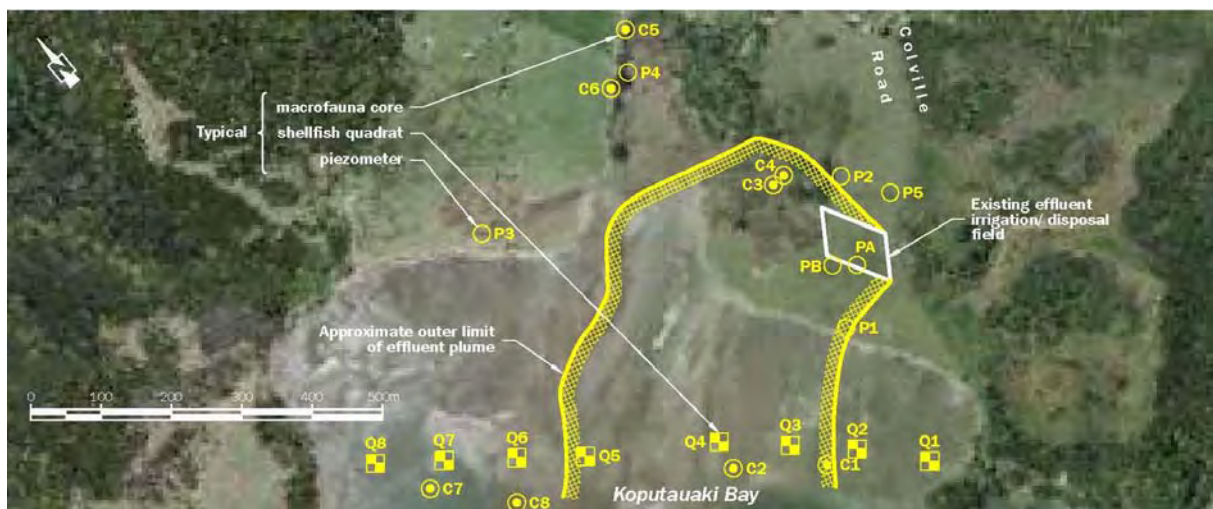
**Figure 2.** Sampling and monitoring locations.

The last two of these three specialist investigations also involved collection and analysis of samples from control sites, remote from the effects of the irrigation field. Sampling and monitoring locations for all of these second-phase investigations are shown in Figure 2 below.

The extent of the effluent plume in the groundwater flow, and the location of the irrigation field itself, are indicated in Figure 2.

Sampling locations for both the initial and second benthic surveys are shown in Figure 2.
