# PETROLEUM HYDROCARBON CONTAMINATION INCIDENT AT CHRISTCHURCH CITY COUNCIL GROUNDWATER PUMPING STATION

*G. Knogle; Pattle Delamore Partners Ltd  
A. Beard, B. Henderson; Christchurch City Council*

## ABSTRACT

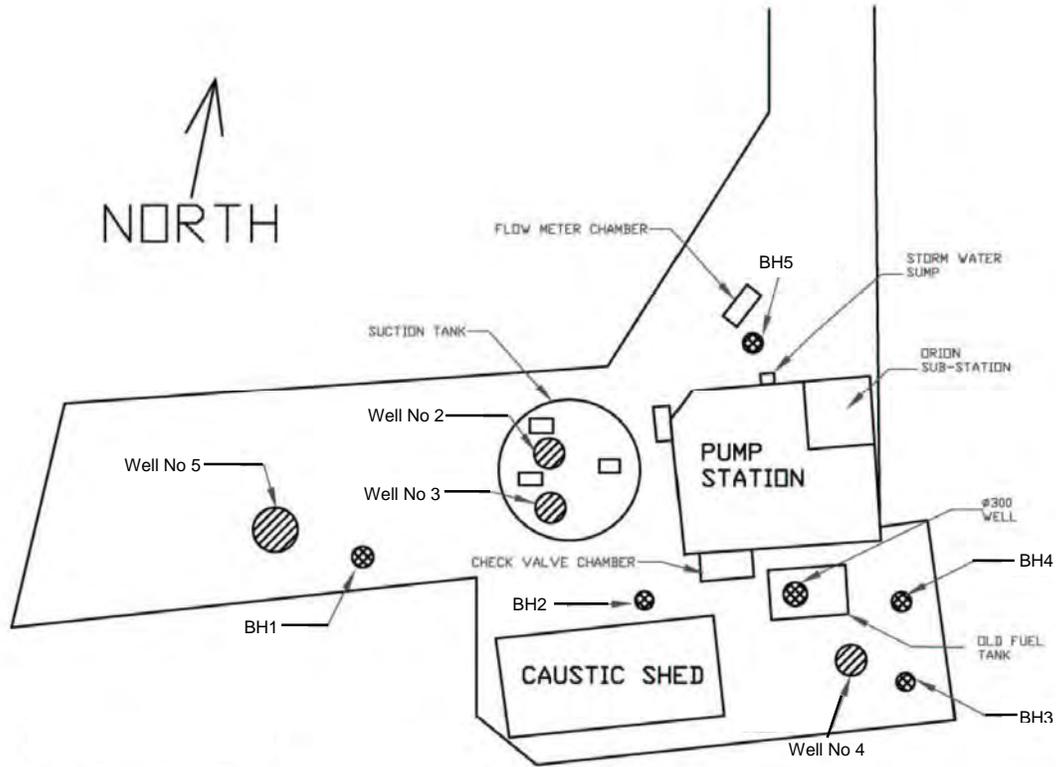
Figure 1: Plan view of Auburn Ave Pumping Station

PDP supervised the drilling of five groundwater monitoring boreholes at the pumping station between 24 and 25 March (BH1 to BH3) and 2 and 3 May 2003 (BH4 and BH5). The wells were installed to further define the lateral extent and hence impact of the petroleum residues released into the surrounding ground. The locations of the installed groundwater monitoring wells are shown in Figure 1.
