# LOSS OF SUPPORT FROM BELOW – FAILURE OF WASTEWATER TREATMENT LAGOON

*Azam Khan & Neil Crampton - Pattle Delamore Partners Ltd, Auckland*

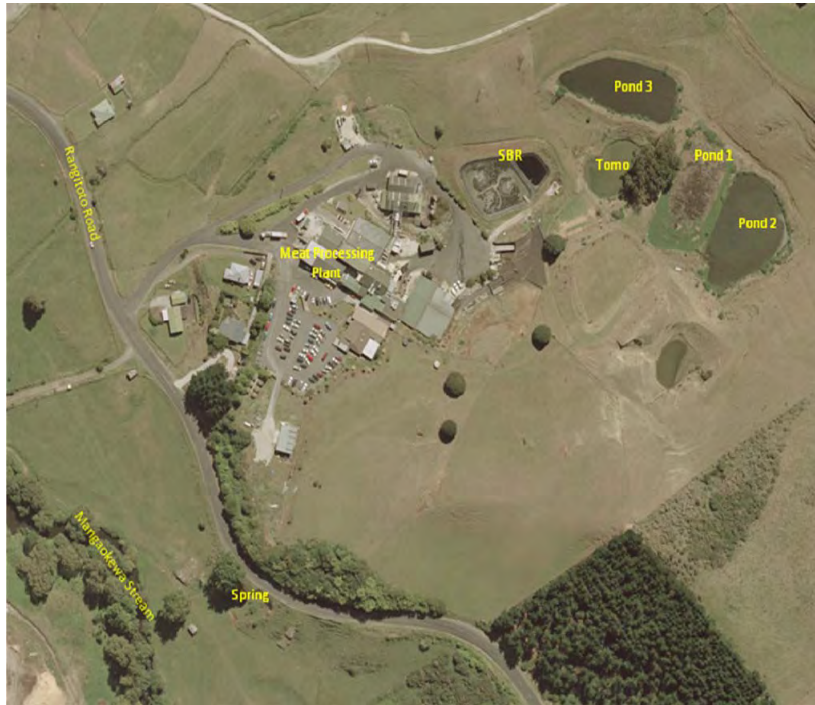
The meat processing plant is located on a secondary ridge near the bottom of the Mangaokewa Stream valley approximately 2 km south-east of Te Kuiti. The meat processing plant and the wastewater treatment system are shown in Photo 1. The anaerobic lagoons at the site are located on elevated ground approximately 200 m north-east of the meat processing plant and the SBR is located adjacent to the north-east edge of the plant area.

*Photograph 1: Aerial Photo Showing Meat Plant – Te Kuiti*
