# "NOT-MODELLING" FOR STORMWATER AROUND THE KAIKOURA ALLUVIAL FANS

*Mark Pennington*

*Pattle Delamore Partners Limited, Kaikoura, New Zealand*

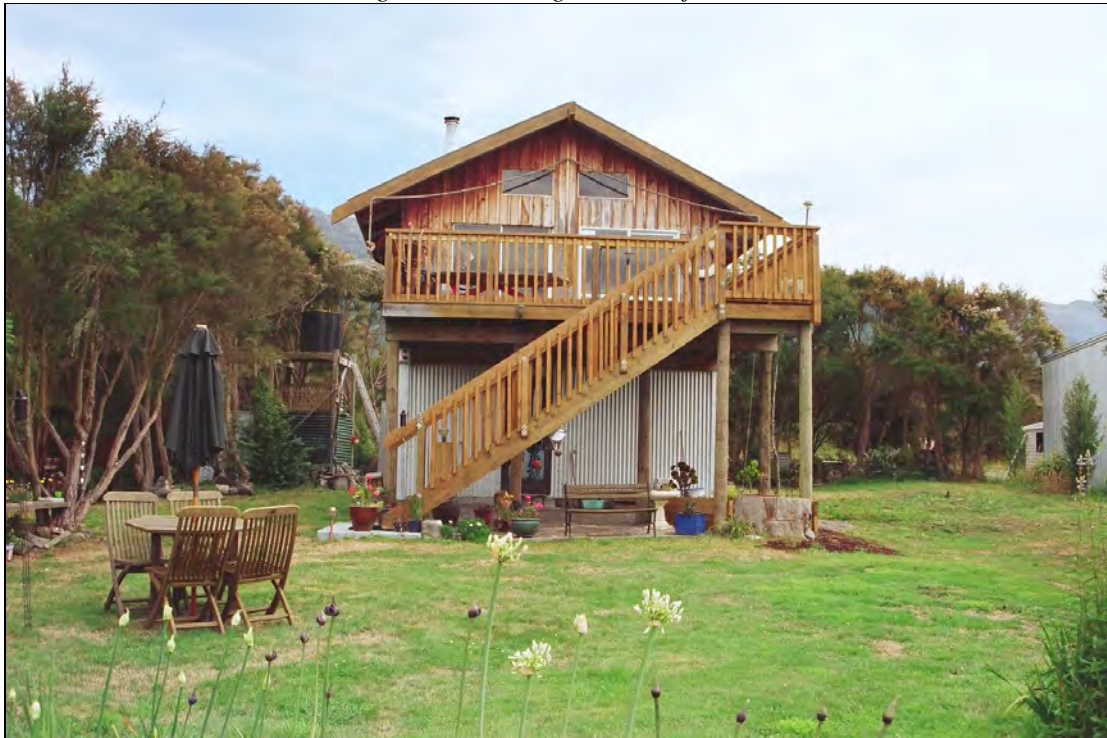
*Figure 4: Dwelling at the Subject Site*

Some time back an unconsented dwelling was built on this site and the property was subsequently sold. The dwelling was constructed on poles so that it was well clear of potential floodwater coming from the Waimangarara River. The new owner proposed some modifications to the dwelling, including closing in the ground floor, for which building consent was sought (retrospectively). The dwelling is shown in Figure 4.
